Laboratory Structural Test Report

Sample type: Insulated Concrete Form (ICF) Wall + Expandable Polystyrene (EPS)

Test sponsor: Alrayyan Building Insulation for Industry Co

Report number: DLR3520

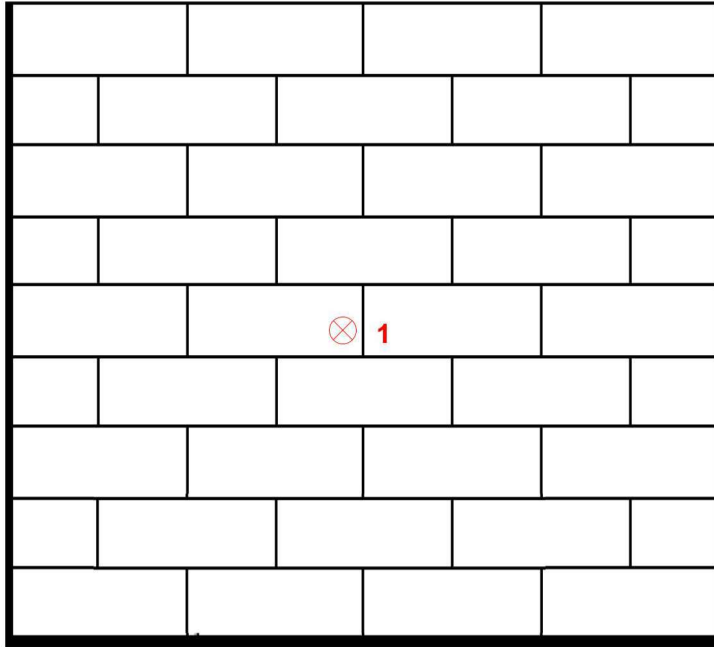
Figure 2 Deflection gauge location (as viewed from outside)

Deflection gauge

The measurement positions are shown in Figure 2 in Appendix A. Please see table below for the methodology of the displacement gauge positioning.

Wind resistance - serviceability		Pass	
Date	23 Jan. '25	Time	10:00am
Tables 6 & 7 below show the gross deflection, in mm, for gauge location 1 at the centre of the concrete wall.			
No visual damages were observed.			
See Figure 2 in Appendix A for the gauge location.			
Ambient temperature	21 °C	Relative humidity	60 %
